**APPRAISAL OF WATER SUPPLY FACILITIES IN RURAL RIVERINE
COASTAL AREAS OF LAGOS STATE**

E.O. Longe, O.B. Omotoso and G.A. Sodamade
Department of Civil and Environmental Engineering, University of Lagos, Nigeria.

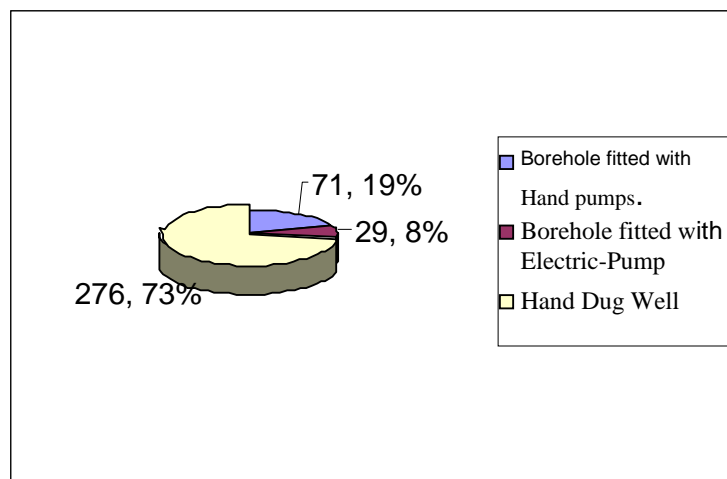
The communities depended mostly on boreholes mostly fitted with hand pumps and electrical pumps and hand dug wells. There were 376 of such facilities in the entire 43 communities. Hand dug wells were 276 in number, while boreholes fitted with hand-pumps and the ones fitted with electrical pumps are 71 and 29 respectively.

Figure 2: Facilities in the Communities

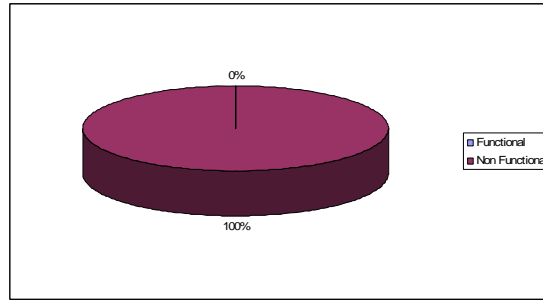
From observation, all the 71 boreholes fitted with hand pumps available in the communities were out of order (Figures 3 and 4). Boreholes fitted with hand-pumps did not fair well either, 84% of these boreholes had failed mostly due to failure of the pumping system as shown in Plate 1. However borehole failure could also be attributed to corrosion of hand pumps and effects of salt water intrusion.

Fig. 3: Boreholes Fitted with Hand-Pumps

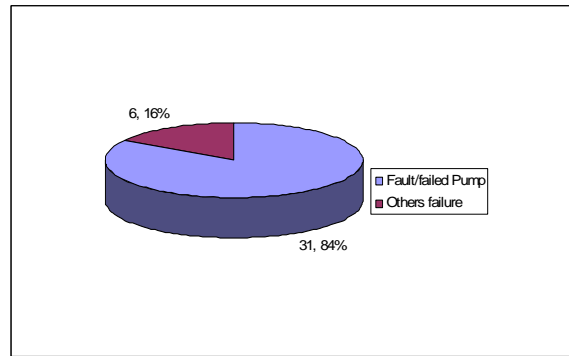
Fig. 4 Mode of Failure of Boreholes Fitted with Hand-Pumps

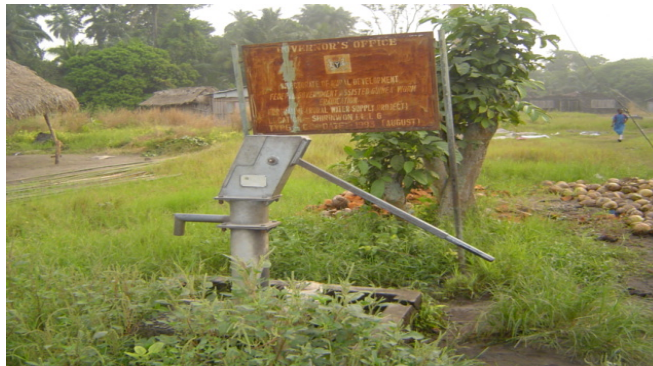
Plate 1: Abandoned Borehole Fitted with Hand Pump at Siriwon

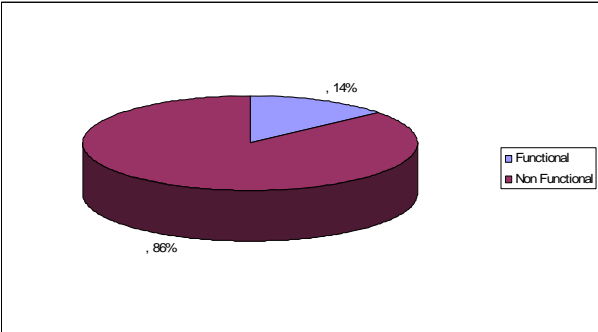
Failure due to the latter represented about 16% of the failure borehole failure observed. Out of 29 boreholes fitted with electrical pumps, only 4 were functioning, while 25 were out of order. Figure 6 shows the mode of failure of boreholes fitted with electrical pumps. Common reasons for failure included faulty pumps (40%), no source of power (18%), absence of pumping machine (18%),

Figure 5: State of Boreholes Fitted with Electrical Pumps

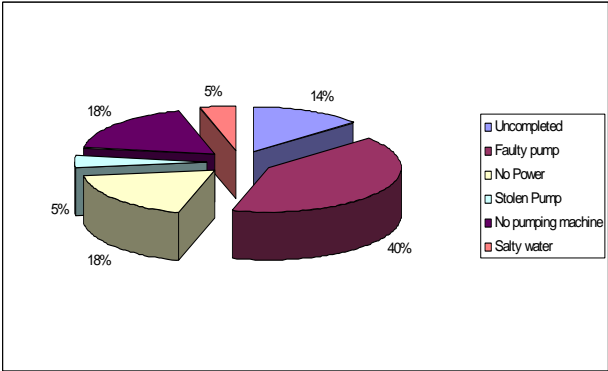
Figure 6: Mode of Failure of Boreholes Fitted with Electrical Pumps

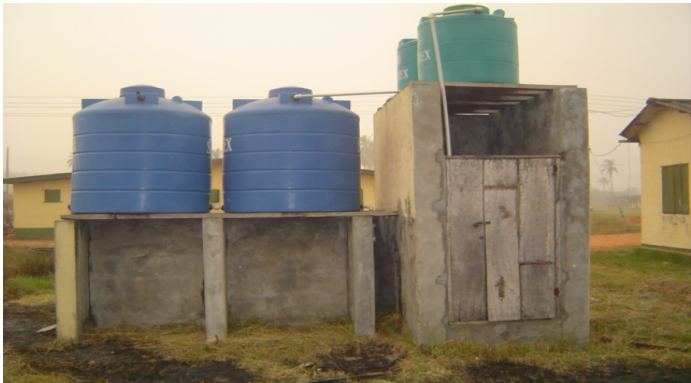
uncompleted (14%), and abandoned due to salty water intrusion represented 5% as indicated in Plate 2.

Plate 2: An Abandoned Borehole Fitted with Electrical Pump at Ebute-Lekki

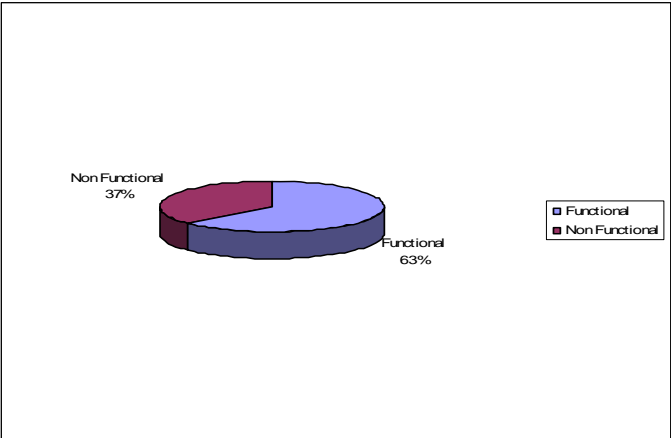
From Figure 7, 37% of the hand dug wells were not functioning due to salt water intrusion, which increased the iron content and created a dry well situation (Plate 3), while 63% were functional. It was also observed that the people resorted to hand dug wells due to failures of government water

Figure 7: State of Hand Dug Wells

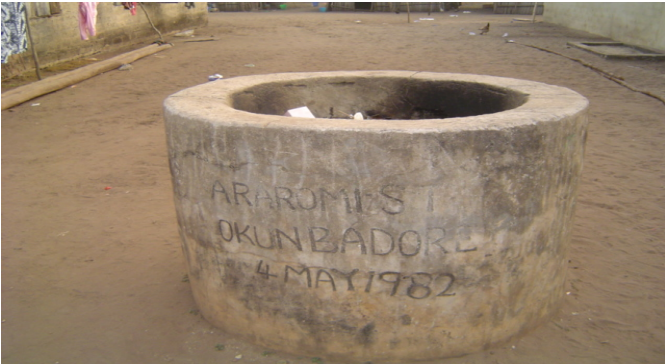
Plate 3: A Dried Well at Okun Badore

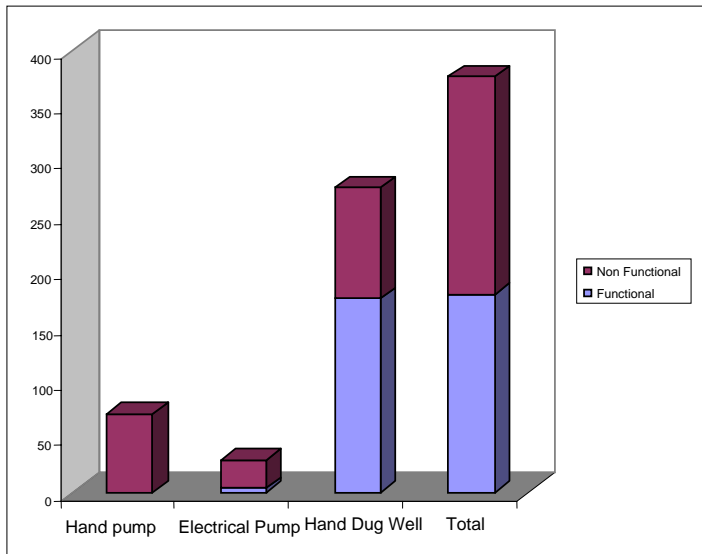
Figure 8: Global View of the Facilities in the Communities

Globally, out of 376 water supply facilities, 179 of the facilities representing only 47.6% of the entire facilities were functional while 197 representing 52.4% were non-functional. From Figure 8, hand dug wells performed better than the boreholes fitted with hand-pumps.
