LONG TERM LAND -USE CHANGES AND IMPACTS ON GULLY DEVELOPMENT IN SOUTH ETHIOPIA

Engdawork Assefa,

Center for Environment and Development, College of Development Studies, Addis Ababa University

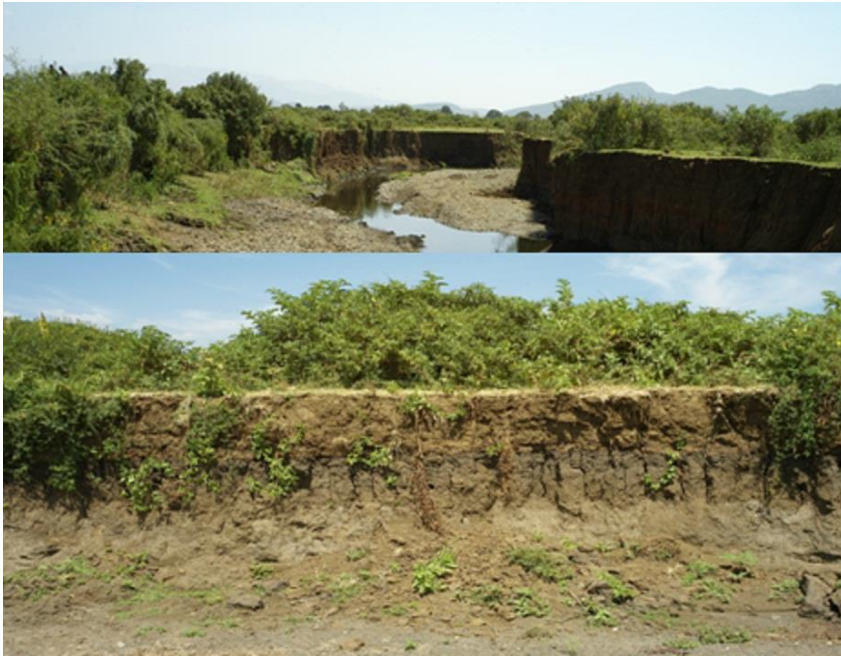
Figure 7: Gully of Lower Hare Watershed

In the investigated gully profile (figure 5) in the flood plain of Hare river, a fine soil material was deposited in a thickness of more than 2.5m (Table 3). Loamy floodplain sediments are dominant. In the upper part of the profile, runoff intensities have been higher and sand was deposited there. The floodplain sediments contain the lower segment of a buried trunk of an acacia tree, which is still in its original position. The acacia tree started to grow on top of layer F1, before layer F2 started to be deposited; on a former soil surface, which is buried today at a depth of 239 cm below the recent surface. The acacia tree grew during the period when F2 and the lower part of F3 were deposited. Then, humans cut the trunk and burnt the cut surface, at the latest after F2 and 55 cm of layer F3 were deposited. The trunk has a maximum diameter of 15 cm. Since the tree is not decomposed at all, a young age in the middle and upper part of the sequence (F2-F4) is probable. We can conclude that erosion increased intensively when the clearing of the woodland on the steep slopes of the escarpment of the rift valley and agricultural land use began some decades ago.

The extreme intensification of sedimentation caused severe problems in the wide floodplain of the lower Hare River. Sediments covered woodland as well as arable land. Intensive land use had to stop in these areas.

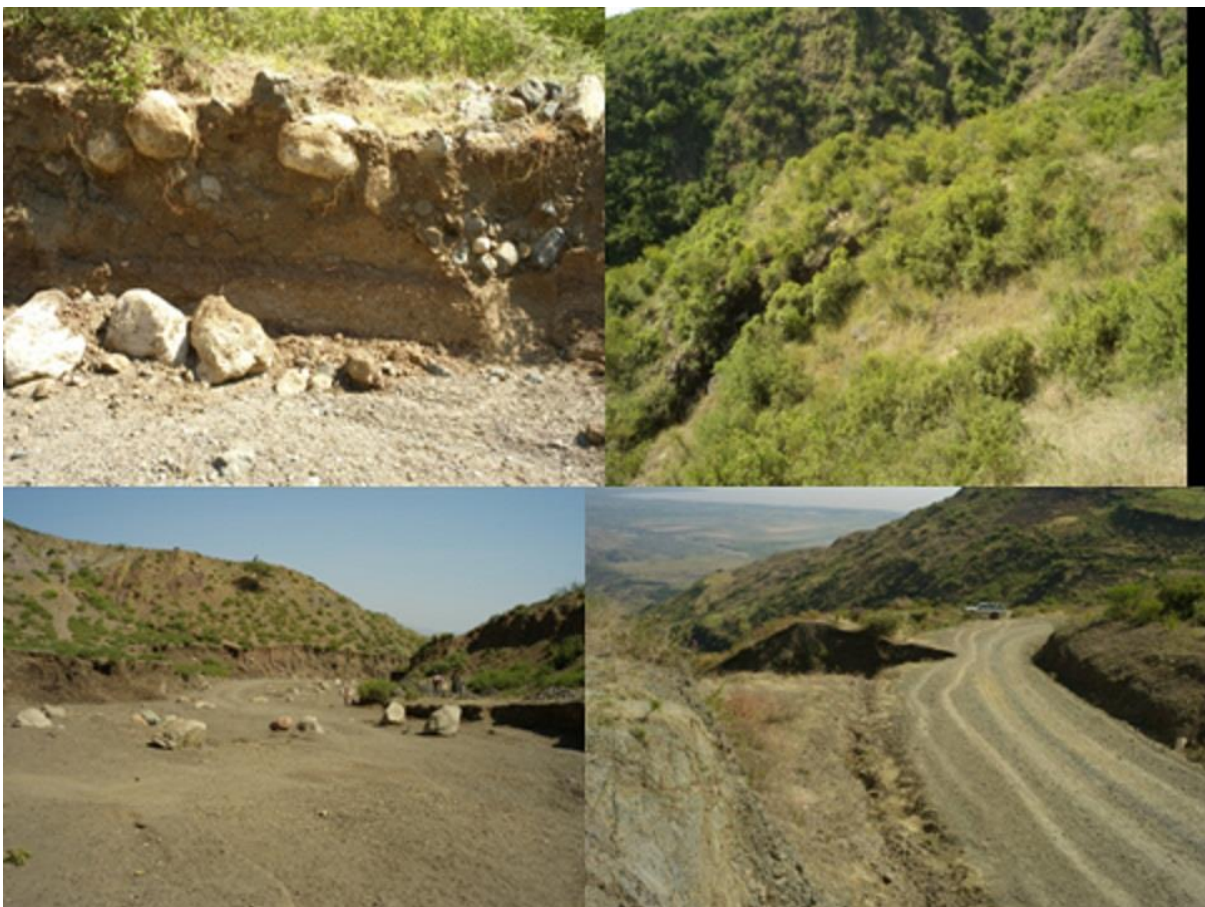
Figure 8: Gully of Zigetie

Zigetie area, in the Arbamich Rift Valley escarpment, has a prevailing feature of deep tension and desiccation cracks (figure 6). In the middle segment of the escarpment a complex gully system was identified. A gully has cut 3 to 8 m deep here, into fine-layered sediments which fill an older gully. The development of the gully system could be reconstructed as follows:

A first gully cut into non-compacted sediments. The age of this first period of gulying is unknown. Then this first gully was filled with thin-layered sediments. The fine layering is the result of several heavy rainfall, and thus runoff and hillslope erosion, events in the catchment of the gully. Runoff generation, hillslope erosion and sedimentation were enabled by the clearing of parts of the escarpment, which started approximately half a century ago. In the middle of the fine layering a large stone was observed, which gravitational processes had transported into the gully from the neighboring slope; this gravitational process may have been the result of an earthquake. Today, the primarily fertile soils on the slopes are mostly eroded. Thus soil fertility on the segments of the escarpment which were used agriculturally for up to half a century has been reduced dramatically. At some sites agriculture has therefore ended or will cease in the near future for a long period of time; until new soils have formed from the bedrock which is exposed there, namely by chemical weathering processes requiring at least several centuries.

After the first gully was almost completely filled with fine-layered sediments, a second gully cut into these gully-sediments, right down to their base. This second phase of gulying was enabled by the construction of a road(to connect Arbaminch town with the highlands), which took place in 1981 above the catchment of the gully(figure), . Runoff concentrated on this road and flowed down it during heavy precipitation events. These masses of water were concentrated into the filled first gully, and thus caused the incision of the second gully. Without the road construction, the filling of the first gully would have continued.

After the construction of the road, flooding, erosion and deposition of sediments caused severe damages in the lower segment of the gully system near Arbaminch. These processes are still active.

This example of sudden gullying proves the sensitivity of the escarpment ecosystems of the rift valley. Forest clearing and then agriculture enabled runoff generation, hillslope erosion, and thus a slow filling of the first gully, while infrastructure measures immediately resulted in strong gullying. In the uppermost part of a neighboring catchment, gully erosion already has removed a part of the road.

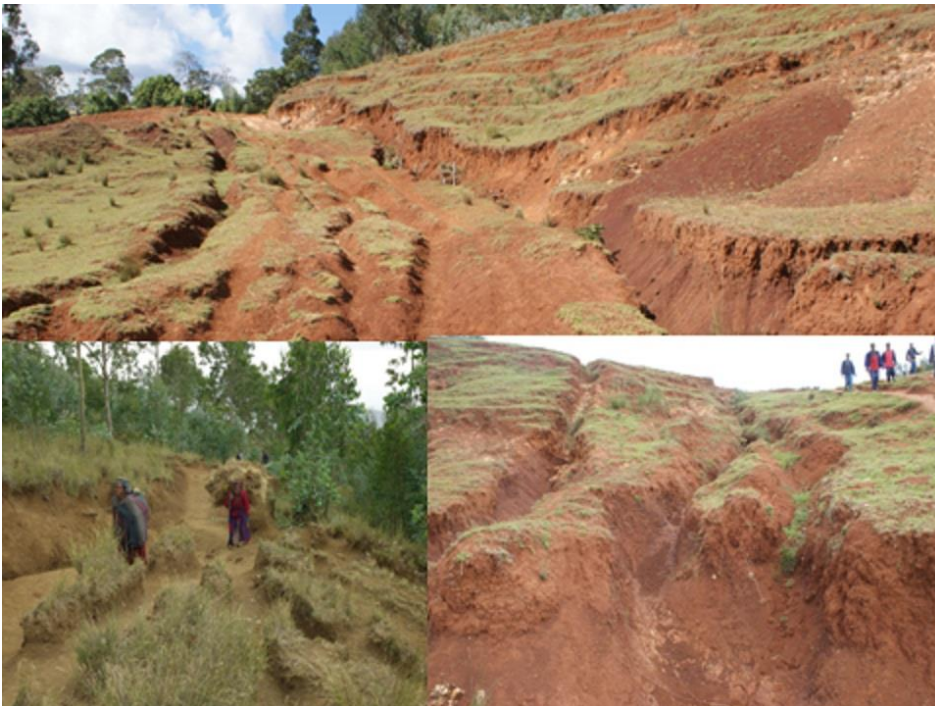
Figure 9: Gully of EzoGulle

A sequence of almost parallel gullies has developed during the last four decades in EzoGulle area (figure 7). Gullying started with the establishment of a path which was leading down a steep slope, and which was used frequently by humans and animals. Since the weathered bedrock has a low infiltration capacity in this area, runoff was already generated during minor intensive precipitation events.

When the first gully was cutting in, people and animals continued to use the path. When retreating erosion caused the generation of steep steps in the gully, it could no longer be used as a path. Then people and animals walked a few meters to the side of the gully and a new path developed there. Due to the compaction of the soil along the second path, runoff generation began there during precipitation events.

The subsequent heavy rainfall events resulted in the undercutting of the walls and the bottoms of the gullies, leading to their deepening and widening. This also caused the collapse of gully walls. More heavy rainfall events with concentrated runoff, coupled with land use changes, triggered more erosion and further deepening, widening and extending of gullies downslope. In addition, the retreat of the head gully cutting was also observed.

A second gully started to develop. The development of the second gully followed in the same way as the first one. After some years, people had to give up the second, now incised, path. They used the neighbouring space, where the development described then occurred a third time, causing the development of a third deep gully. The gullies have cut into the lower and middle slope segments, causing the deposition of sediment in the grassland of the adjacent valley. Thus, to date a sequence of gullies has developed merely as a result of soil compaction by human activities along the small lines.

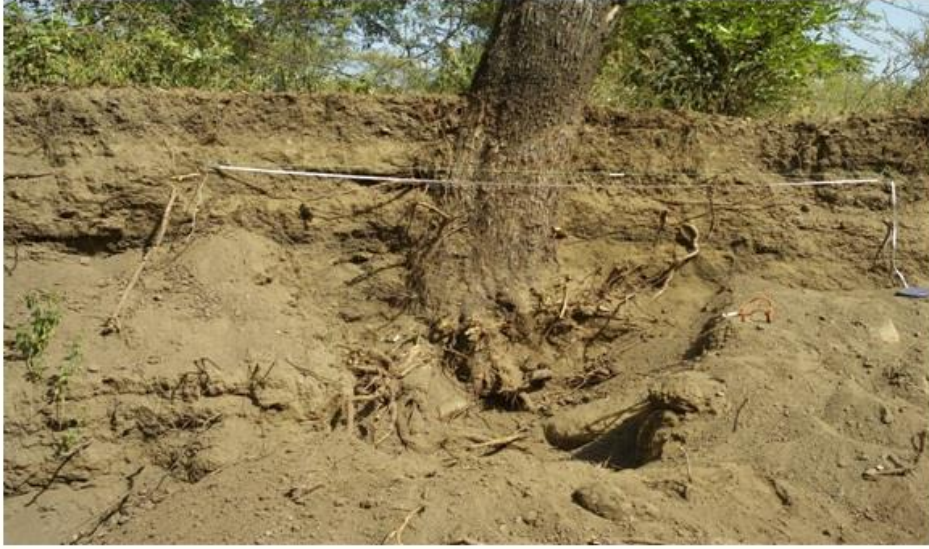
Figure 10. Gully of ChanoChelba

11. Gravel was deposited in the second ChanoChelba gully during several medium intensive precipitation and runoff events, with a thickness of 1- 2 m.
12. During a heavy precipitation event with concentrated runoff mainly on paths, the third incision of ChanoChelba gully system proceeded. The third gully has a depth of 1.5 m.

13. During several medium intensive precipitation and runoff events, gravel was deposited in the second gully to a thickness of a few decimetres.
14. The fourth (and until today, last) incision of the ChanoChelba gully system occurred recently, during a heavy precipitation event with concentrated runoff on paths. The third gully has a depth of several decimetres.

We have also observed geomorphic stability phases that occurred between the incisions and aggradations. For example, in ChanoChelba during two phases of geomorphic stability in the catchment of the gully, soils were formed under vegetation, namely forest, on the deposited material. The trees were planted and provided cover for the ground and consequently low runoff generation.

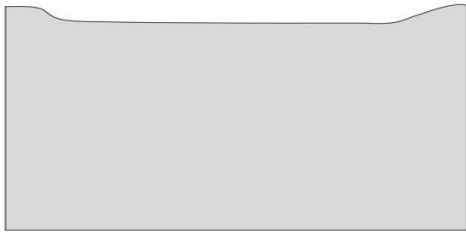
Figure 11. ChanoChelba Gully System

A Initial situation

B Intensive flood erods first gully

C Several minor floods deposit sediment

D Woodland grows (stability of surface)

E Several minor floods deposit sediment

F Intensive flood erods second gully

G Several minor floods deposit sediment

H Intensive flood erods third gully

J Several minor floods deposit sediment

K Intensive flood erods fourth gully

L Landscape in 2009

It is evident from our investigation that the gully development had a pattern of cut-and-fill cycles. Gully cycling is marked by the processes of filling, which take place during periods of several years, interrupted by individual rainfall and runoff events with incision. For instance, in the gully system of the Zighetie area, the filling of the gully was interrupted by a deep incision. The backfilling could have continued for a somewhat longer period if the road had not been constructed. This road was a cause for generating high runoff, which led to the entrenchments. Similar observations were made for the ChanoChelba gully system in which depositions or back filling was interrupted by cutting which was enabled by deforestation, cattle grazing and road construction in the catchment of the gully. We observed four cut-and-fill cycles that occurred during the last century in ChanoChelba. This also shows the dynamics of the driving factors, which are responsible for cutting and backfilling. The incision-aggradation cycles were also reported for the late
