**THE DETERMINANTS OF NON-REVENUE WATER IN SHURUGWI TOWN:**

**A CASE OF MAKUSHA RESIDENTIAL AREA.**

Tinashe P. Kanosvamaha and Mark Matsa

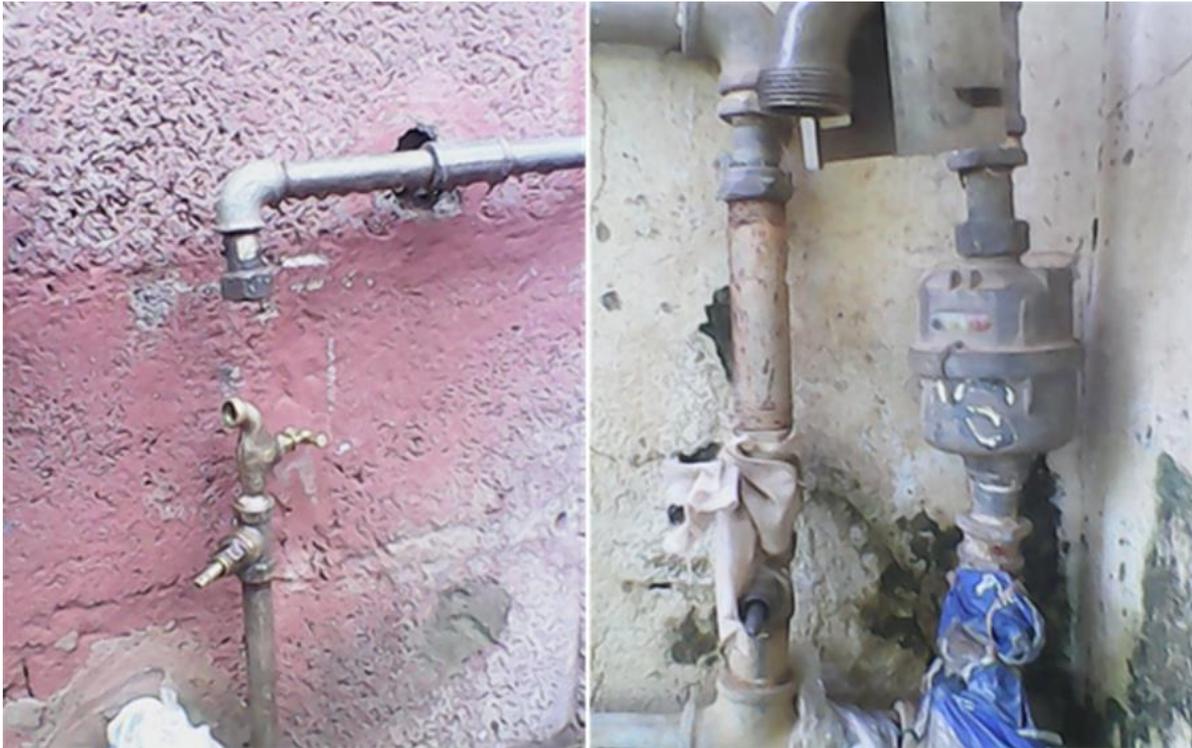
Plate 1: Illegal connections identified in Makusha residential area

The questionnaire survey revealed that 75 (68%) respondents had witnessed illegal water usage in the community within the previous six months. Most respondents had witnessed meter by-passing and illegal connections as the most dominant mode of illegal water usage. However, meter by-passing could not be identified through the observation exercise as Farley (2008) notes that, it is difficult to detect as the by-passing pipe is usually installed underground to prevent detection. Illegal fire hydrant usage was the least dominant mode of water theft witnessed by respondents in the area. Direct observations discovered at least 2 households practising water theft in the form of illegal connections (Plate 1). Similarly, Ainuson (2010, p. 68) conducted a study in Ghana, which reported a prevalence of illegal water connections in the communities of Ashalley Botwe, Nima, and Ashaiman. The LID Agency Project Officer maintained that water theft was quite prominent in the area because of illegal miners who interfered with the water system to access water from main pipes. Moreover, he corroborated that the uneven terrain prevented water from reaching households located on higher ground hence residents obtained water from households with vandalized meters at lower gradients. This exacerbated the levels of water theft in the community.

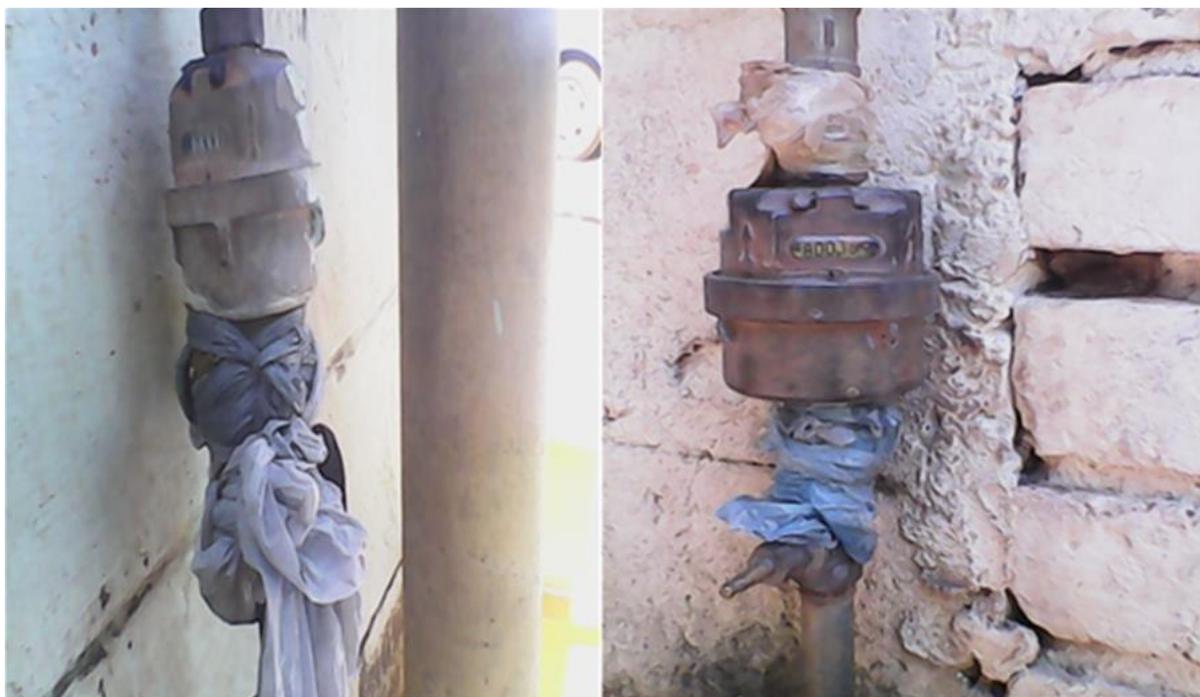
Plate 2: Two sealed leakages identified on meters in Makusha residential suburb

The town council had already revamped the water treatment plant hence leakages at the reservoir and overflowing tanks were halted. This is commended as Stevance (2015) notes that Sustainable development goal (SDG) number 6 recognises that ensuring universal access to safe and affordable drinking water by 2030 will require investment in adequate infrastructure. Therefore, this indicates a positive investment by the town council. Nonetheless, a total of 81 respondents reported witnessing leakages on water pipes and service connections over the past six months in Makusha. This prevalence of leakages was not alarming considering that the infrastructure is severely old and dilapidated hence burst pipes and leakages were expected. Most respondents indicated that leakages occurred along service connections before the meter (Plate 2). Observations assisted in identifying the leakages which occurred just before the meter. These could be identified despite the absence of water as there was evidence of attempts at sealing the leaking pipes by residents (Plate 2). This form of leakage is usually visible and costs the water utility as the water leaks before it is charged for consumption hence consumers might not even take heed of it as it does not affect their water bill (Farley, 2003). Although some residents attempted to seal the leakages it was with minor success as observations revealed that most residents used an elastic and plastic material to seal leakages which were not suitable, as a result, leakages continued.

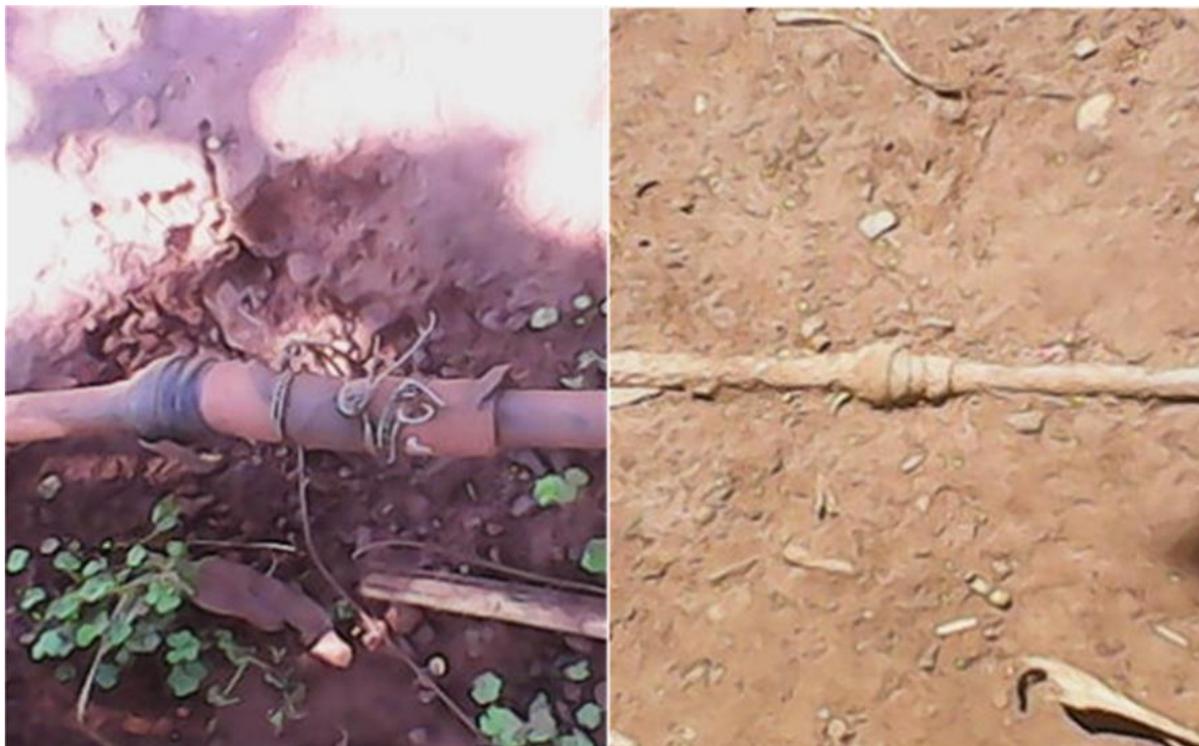
Plate 3: Two leaking pipes identified along service connections in Makusha residential area

Only two leakages were identified along visible service connections during the observation exercise (Plate 3). Just 3.7% of the respondents had witnessed bursts on main pipes which are not very difficult to detect due to high pressure in the main pipes. Identifying leaking and burst pipes was difficult since there was no water at the time of the investigation as a result of the intermittent water supply. A total of 81 respondents had come across leakages on pipes during the course of the previous six months. Only 36 of these respondents reported the identified burst pipes to the town council. Failure to report burst pipes by the remaining 55 witnesses implies that a significant portion of revenue was lost through leakages. On the other hand, Manzungu & Machiridza (2005) in their study in Harare discovered that the majority of sampled residents (81%) reported leakages to the Harare City Council. Their findings indicated that this was good practice as it enabled the water utility to repair leakages in a timely manner preventing physical water losses. The town council
